**Tree Inventory and Preservation Plan Report
5 & 15 Tangreen Court
Toronto, Ontario**

26 January 2023, revised 12 February 2023, 15 February 2023, 10 March 2023

KUNTZ FORESTRY CONSULTING INC Project P3627

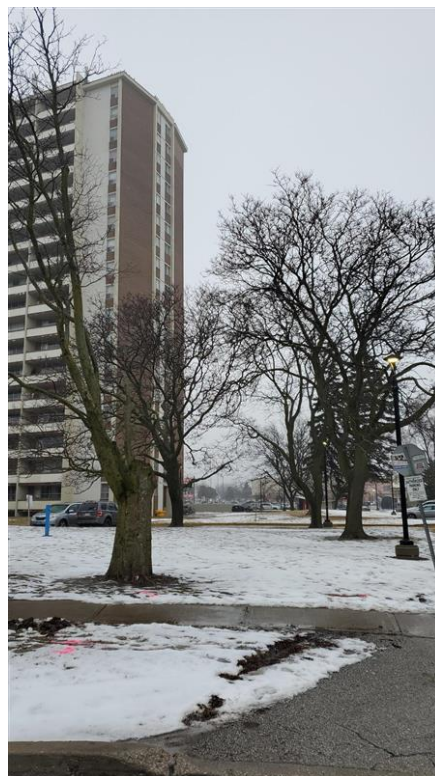
Tree 140 – 143

The removal of trees 140, 145, 176, and 199 is recommended regardless of the site plan due to their condition. Trees 199 and 232 are dead.

Since Trees 140, 145, and 232 are either dead or in poor condition, they are likely to be exempt from permit requirements.

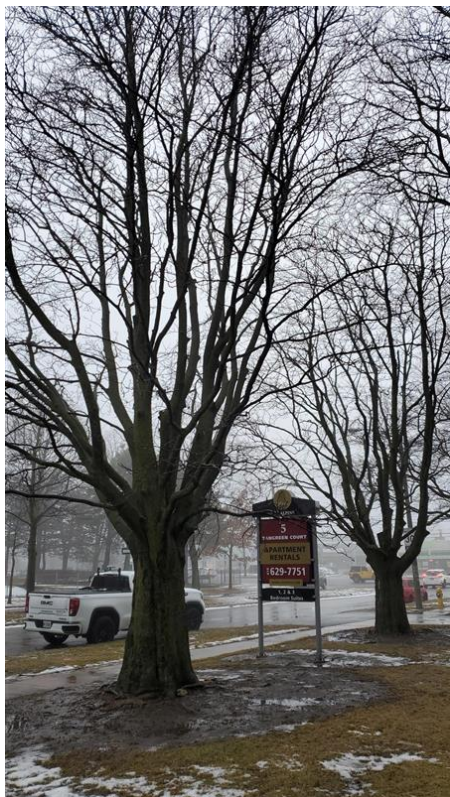
Tree 224 – 225

223	Mountain Ash	<i>Sorbus spp.</i>	53	G	F/P	F	4		3.6	1	Pruning wounds (H), asymmetrical crown (M), poor form (M)	Remove
224	Mountain Ash	<i>Sorbus spp.</i>	62	F	F	F	4		4.2	1	Strangling root (M), trunk injury (H)	Remove
225	Mountain Ash	<i>Sorbus spp.</i>	70	F	F	G/F	4		4.2	1	Strangling root (M), trunk injury (H)	Remove
